THE IMPROVEMENT OF THE RESTORATION WORK IN HISTORIC CITIES IN BRAZIL

Altino Barbosa Caldeira*

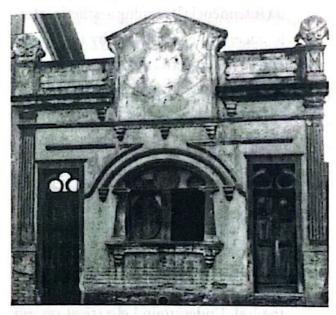
Figure 5 – The art-deco house from the beginning of the century

It was built in the 30's, in art-deco style, to replace an old building which fell down. As its style was in contrast with the others from the 18th century style, the owner and probably also the people from Iphan never accepted this difference. The building was more and more adapted to be similar to the others, by addition of details which make its appearance less of a contrast.

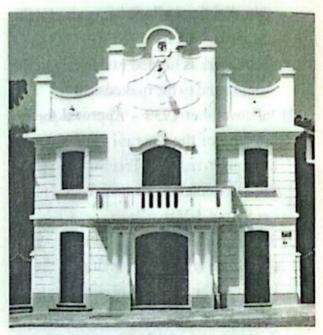
Figure 7 – Theatre front façade: the work of restoration was carried out from 1989 to 1991

The project was planned through an agreement between IPHAN and the City Hall Department of Tourism. As soon as the project was approved, a partnership with the 'Federação das Indústrias' was established to carry out the work in order to provide the building with the necessary equipment and installations (Fig. 7).

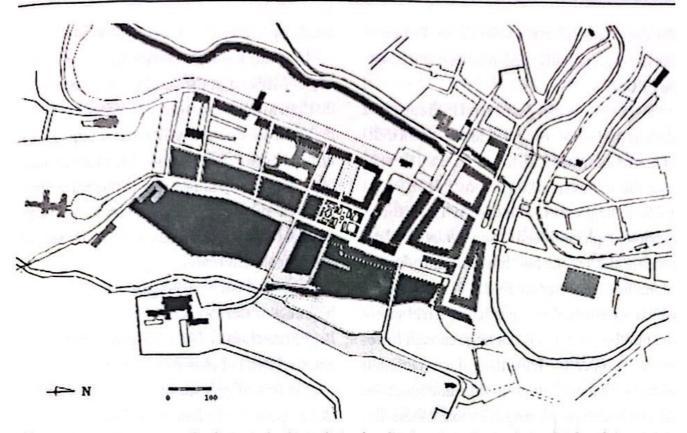
Figure 17 - A preliminary study of criteria for the analysis of applications in Mariana is being developed since 1988

This proposal was first designed by the architect L. Romanelli, in 1988, but received later modifications and improvements through contributions of different sources even from applicants during discussion about their particular requests, in the local office.

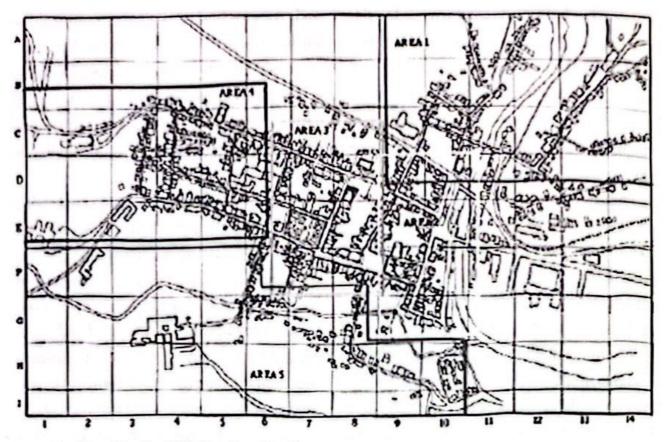
Figure 19 - Map of the city divided into five selected areas:

The map of the city was divided into sections (Fig. 19) so that an in-depth analysis on each section could carried out. It was designed following the same rectangular pattern used to draw the map of 1974 which was made from aerial photographs. The area considered as being the historic city must include Rosário Church in the top right hand corner (1), Santana Chapel in the bottom right hand corner (2), São Pedro dos Clérigos Church at the top left

- · Area 1: at the top right corner-where the city growth initially-is named Rosário;
- Area 2 refers to the second occupation, here named River Bank area;
- Area 3: refers to the first part of the city where the urban design of 1745 was implemented named Low Central area;
- Area 4: named as High Central area, also refers to the Alpoim's urban design implemented in 1745 with some later adittions, and
- Area 5: Old Seminary and Santana area which covers the eastern part of the city which is the one of less density so far.

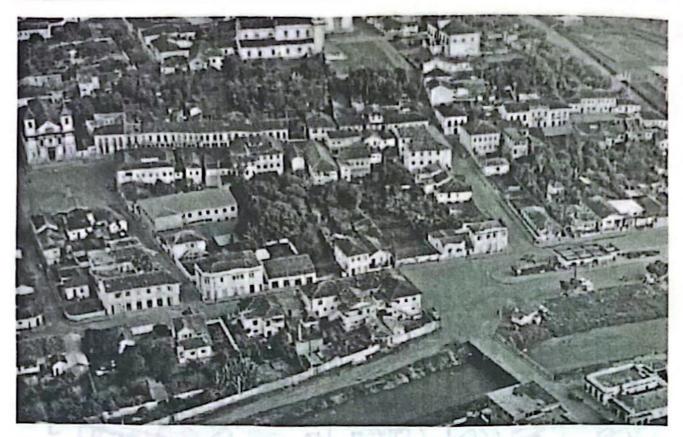
Figure 21 - This aerial photo shows the River Bank area

In the Fig. 21, the Cathedral is at left top side, with Rua Direita at its right side. Josafá Macedo street is at the centre-right coming from the square situated at the top. A new bridge was built to replace this one at the low right side and the river bank received a later retaining walls in concrete which allowed the constructions of many buildings beside the river course, despite a legal limitation.

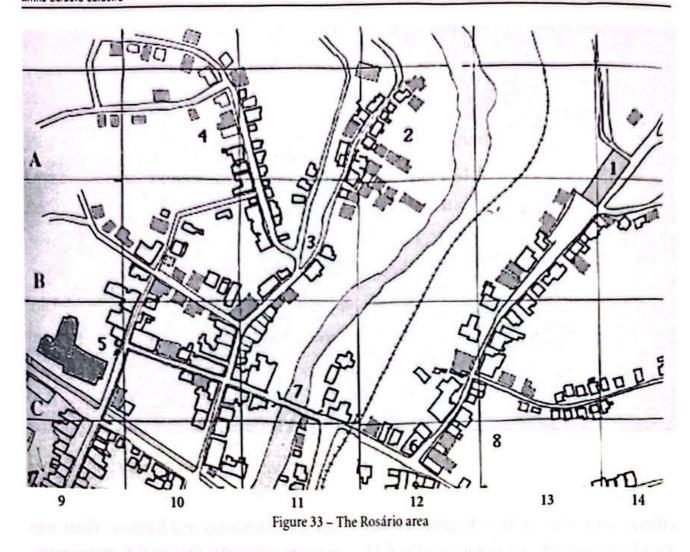
An evaluation throughout the area of the city which is considered as the historic area resulted in the updating of the location of the buildings. The additional historic buildings included in the

area of the historic city since 1974 are indicated. Those which are in state of ruin or which have been demolished since then are also shown as well as the individual listed building of this area.

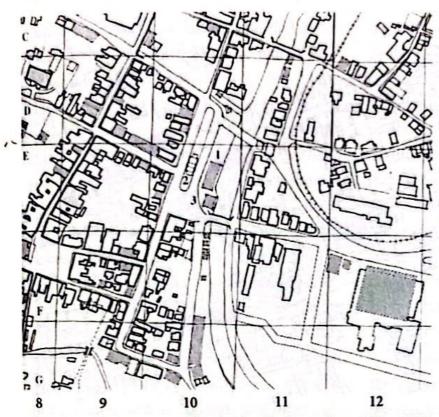
Figure 34 – Changes occurred in the river Bank area from 1974 to 1996 (in Grid F12 the old factory which was replaced by the Gymnasium)

ly the "Rua do Piolho". The River Carmo is now protected by retaining walls at both sides, protecting the city against floods. This area has been constantly modified as a consequence of the city's development and the streets were repaved with new cement paving patterns replacing the original stone cobbles. A great number of buildings suffered extensions without license but some approved projects were built. The map (Fig. 34) shows the proportion of them in relationship with the existing ones to 1974, when the original map was made. The red ones refer to the additional buildings and the yellow to the ones which disappeared since 1974. The buildings in orange are the ones listed individually and the river course is shown in blue. Great changes occurred in the area as shown in the last section through examples of buildings which were lost in this area. These changes can be seen through the aerial view from 1963 (Fig. 21) compared with more recent analysis of the region taken from Iphan archives in the recent survey of the area.

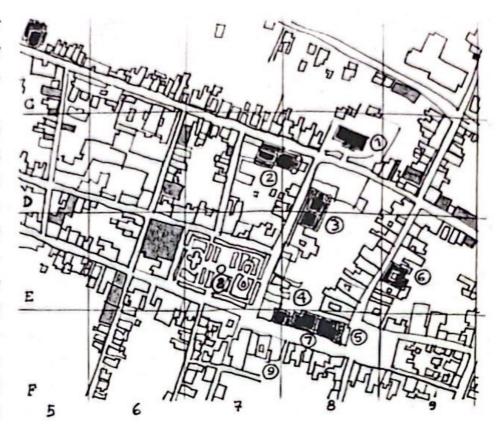
Figure 35 – The transformation which occured in the low central area of the city – Area 3 (new buildings, for buildings subject to demolition or lost, and individualy listed buildings are indicated above)

The original use as residences is being maintained in the area: the first floor in two storey high buildings is always for this purpose. The one storey high buildings mix this use with commercial purposes. In the former cases the ground floors are used for commercial purposes and one level dwellings and shops are balanced in this area. "Rua Direita" with its sequence of two storey buildings at one side and the majority of one storey buildings at the other side is a good example of it. The building which houses Iphan's office is the number 7 in this street, beside the cathedral, and is indicated in brown on the next map. (Fig. 35)

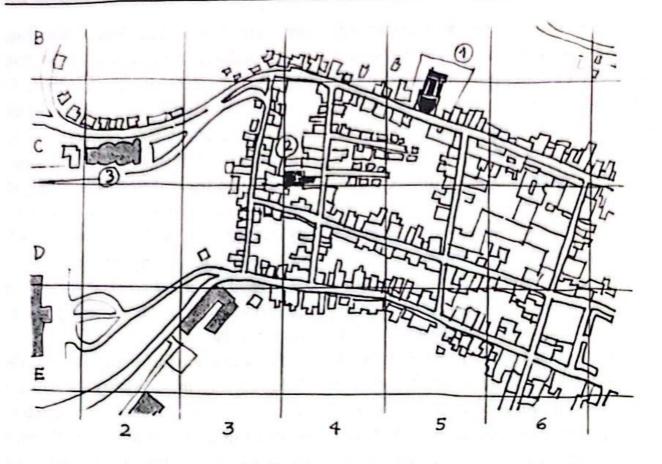
Figure 36 – Changes which occurred in the High Central area from 1974 to 1996 (new constructions, demolitions, additions o rlost, and also the ones individually listed are included)
